Manhole Inspection Summary

Manhole # S33OO_005MH

Insp Date: **6/8/07 12:44 AM**

Location Address: **102 24TH ST**

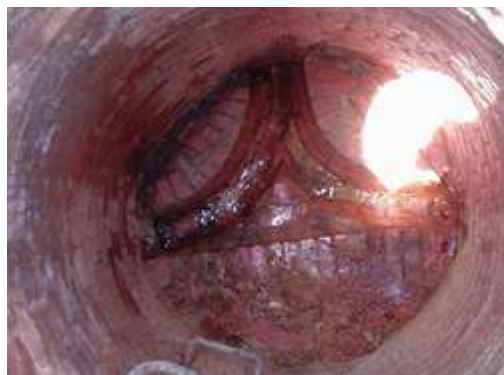
Top View

Evidence of surcharge - Bench debris.

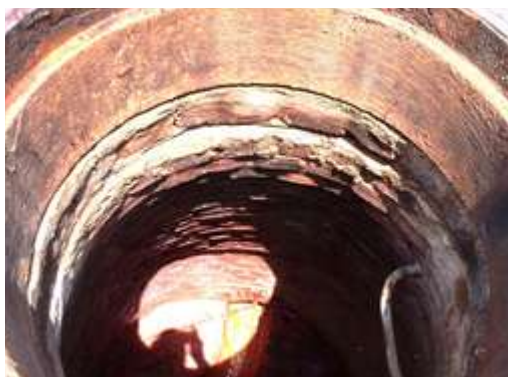
Defect

Frame leaks. Adjustment deterioration and infiltration. Corbel and Barrel infiltration - other side.

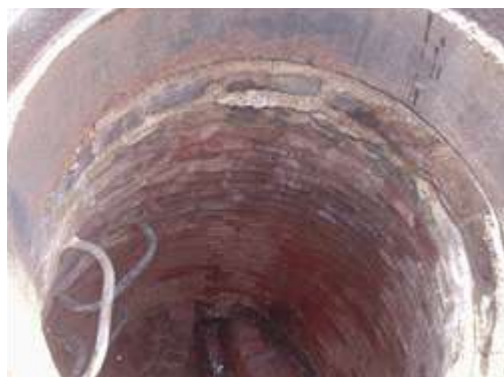
Defect

Frame leaks. Adjustment deterioration and infiltration. Corbel and Barrel infiltration.

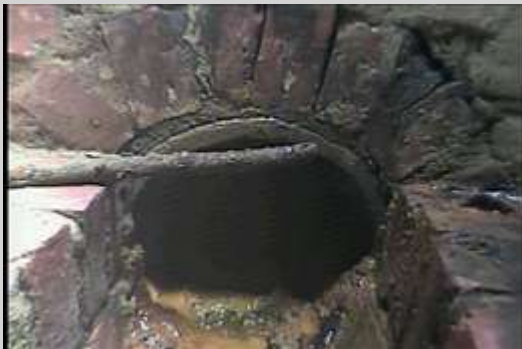
8 in. Circular Gravity Sewer Pipe In @ 3 O'Clock

Deposits: ☐ None ☒ **Mud** ☐ Sludge ☒ **Debris** ☐ Grease

Silt Depth: **0.5** (in.) Deposits Extent: **Light**

Infiltration: **Evidence** Pipe Seal Cond: **Unknown**

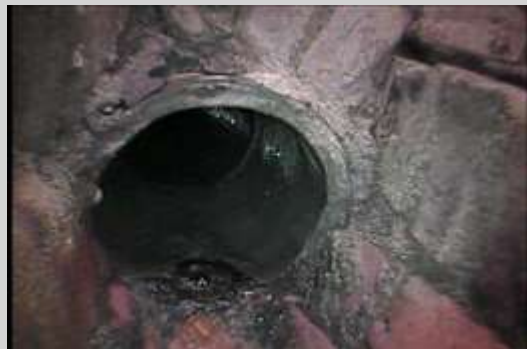
6 in. Circular Gravity Sewer

Infiltration: **Evidence**

Pipe Seal Cond: **Broken**
